Manhole Inspection Summary

Manhole # S33KK1018MH

Insp Date: **4/28/07 9:26 AM**

Location Address: **215 NORTHWAY**

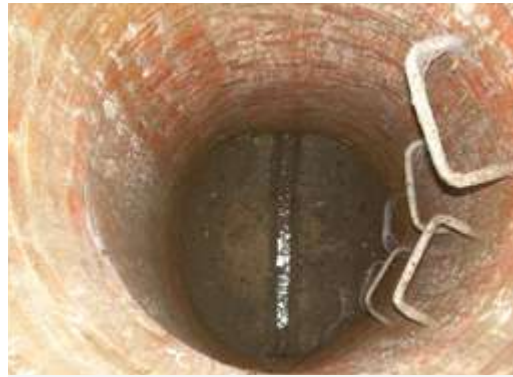
Top View

Bench ☒ Exists Material: **Brick** ☐ Parged ☒ **Debris** (not Condition related)

Surcharge ☒ **Evidence Of Surcharge** Depth: **1** (ft.) ☐ Active Surcharge Present

Evidence of surcharge - Bench debris.

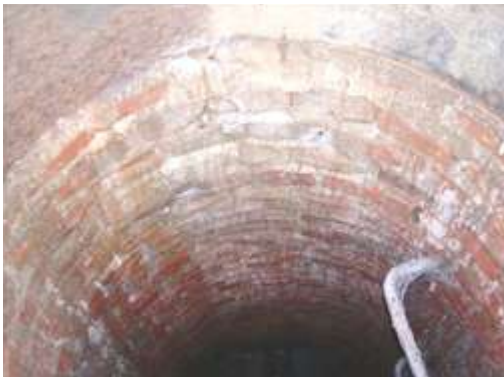
Defect

Frame Offset: **0** (in.) Condition: ☐ Sound ☐ Cracked ☒ **Leaks**

Condition: ☐ Sound ☐ Cracked ☐ Root Intrusion ☐ Loose Brick ☒ **Deteriorated**

Infiltration: ☐ None ☒ **Joint** ☐ Cracks ☐ Mortar ☐ Roots ☒ **Wall**

Infiltration: ☐ None ☐ Joint ☐ Cracks ☐ Mortar ☐ Roots ☒ **Wall**

Frame leaks. Adjustment deterioration and infiltration. Barrel infiltration.

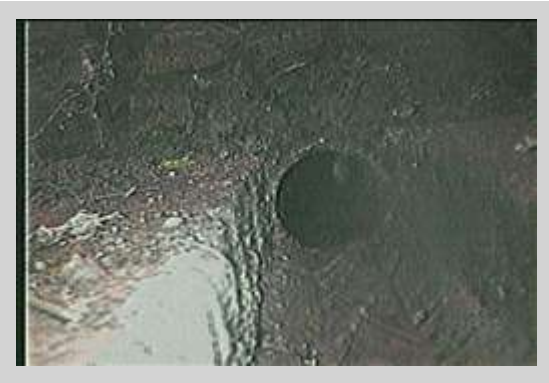
6 in. Circular Gravity Sewer Pipe Out @ 12 O'Clock

Invert Depth: **11.05** (ft.) Flow Characteristics: **Slow**

Infiltration: **None** Pipe Seal Cond: **Unknown**

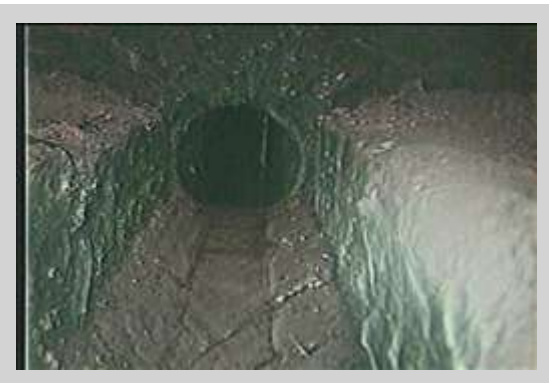
6 in. Circular Gravity Sewer Pipe In @ 6 O'Clock

Invert Depth: **10.91** (ft.) Flow Characteristics: **Slow**

Infiltration: **Evidence** Pipe Seal Cond: **Unknown**
